# Manhole Inspection Summary

## Manhole # S11CC1007MH

Insp Date: **7/5/07 8:50 AM**

**Location** Address: **3934 CEDARDALE RD** Cross Street: **DORITHAN AVE**

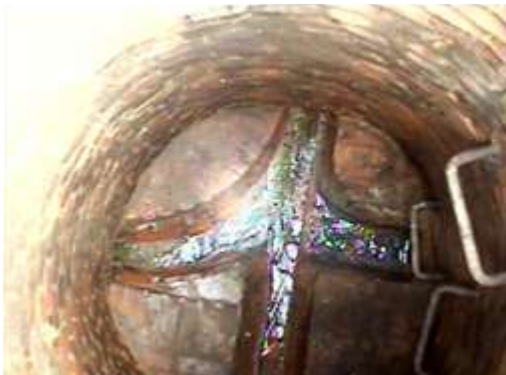
Defect 1

**Steps** Count: **5** Missing: **0** ☒ **Corroded**

CORRODED STEPS

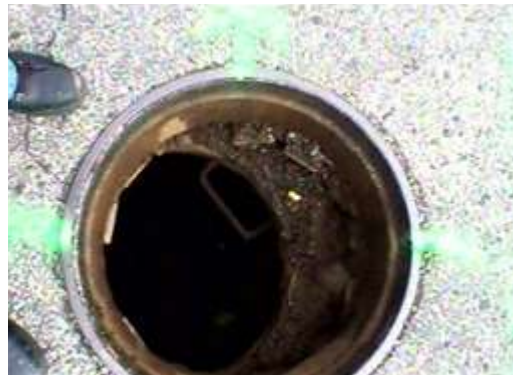
Defect 2

**Frame** Offset: **8** (in.) Condition: ☒ Sound ☐ Cracked ☐ Leaks

Condition: ☐ Sound ☐ Cracked ☐ Root Intrusion ☒ **Loose Brick** ☐ Deteriorated

LOOSE BRICKS - FRAME  
ADJUSTMENT. FRAME OFFSET.

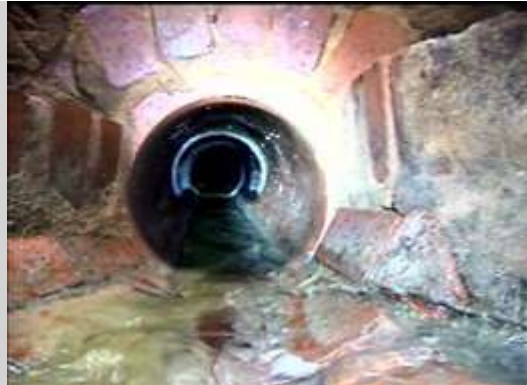
12 O'Clock Outflow

8 in. Circular Gravity Sewer  
Pipe Out @ 12 O'Clock

Pipe Material: **Clay** ☐ Pipe Lined

Invert Depth: **9.11** (ft.) Flow Characteristics: **Slow**

Infiltration: **None** Pipe Seal Cond: **Sound**

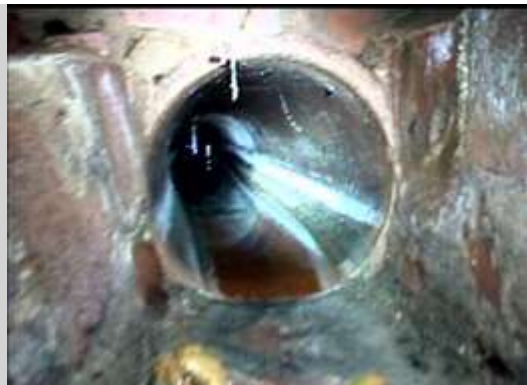
3 O'Clock Inflow

8 in. Circular Gravity Sewer  
Pipe In @ 3 O'Clock

Pipe Material: **Clay** ☐ Pipe Lined

Invert Depth: **8.87** (ft.) Flow Characteristics: **Slow**

Infiltration: **None** Pipe Seal Cond: **Sound**

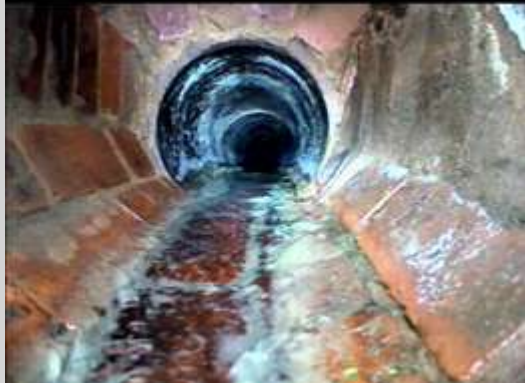
6 O'Clock Inflow

Pipe Material: **Clay** ☐ Pipe Lined

Invert Depth: **8.96** (ft.) Flow Characteristics: **Slow**

Infiltration: **None** Pipe Seal Cond: **Sound**

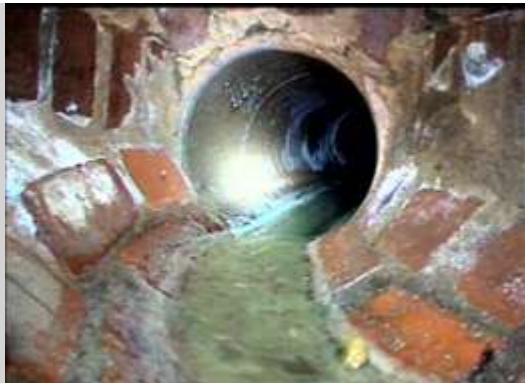
9 O'Clock Inflow

Pipe Material: **Clay** ☐ Pipe Lined

Invert Depth: **9.00** (ft.) Flow Characteristics: **Slow**

Infiltration: **None** Pipe Seal Cond: **Sound**
